Manhole Inspection Summary

Manhole # S19CC1023MH

Insp Date: **3/12/07 12:44 PM**

Location Address: **2095 GIRARD AVE**

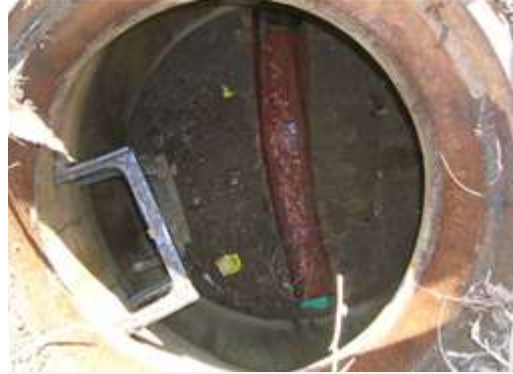
Top View

Bench ☒ Exists Material: **Brick** ☐ Parged ☒ **Debris** (not Condition related)

Surcharge ☒ **Evidence Of Surcharge** Depth: **1** (ft.) ☐ Active Surcharge Present

Evidence of surcharge - Bench debris.

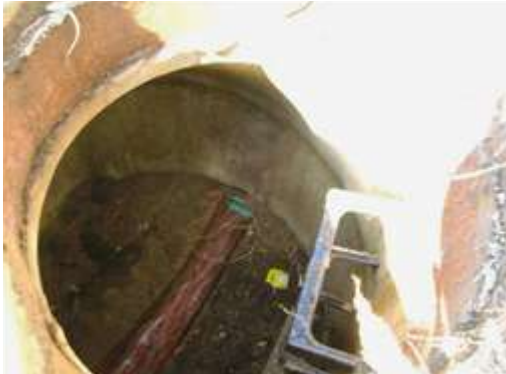
Defect

Frame Offset: **0** (in.) Condition: ☐ Sound ☐ Cracked ☒ **Leaks**

Infiltration: ☐ None ☒ **Joint** ☐ Cracks ☐ Mortar ☐ Roots ☐ Wall

Infiltration: ☐ None ☒ **Joint** ☐ Cracks ☐ Mortar ☐ Roots ☒ **Wall**

Frame leaks. Adjustment and Barrel infiltration.

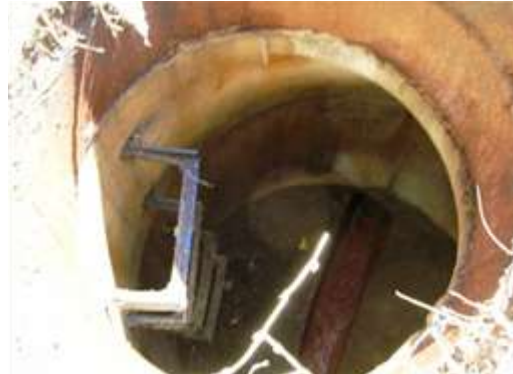
Defect

Frame leaks. Adjustment and Barrel infiltration - other side.

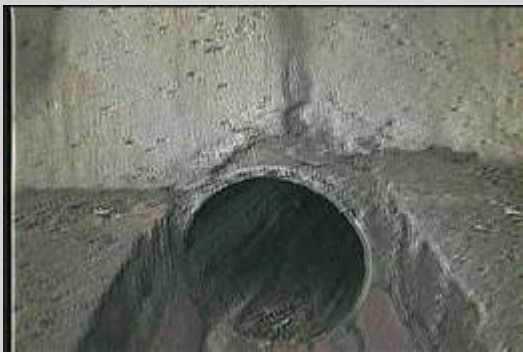
8 in. Circular Gravity Sewer Pipe Out @ 12 O'Clock

Deposits: ☐ None ☒ **Mud** ☐ Sludge ☒ **Debris** ☒ **Grease**

Silt Depth: **0.5** (in.) Deposits Extent: **Light**

Infiltration: **Evidence** Pipe Seal Cond: **Cracked**

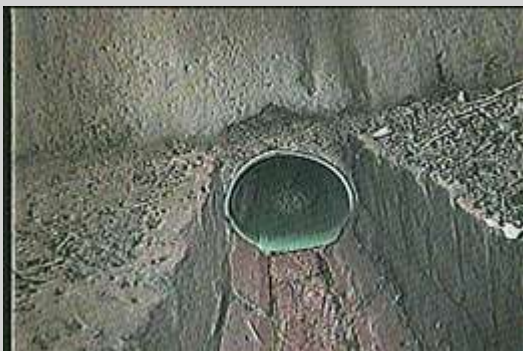
6 in. Circular Gravity Sewer Pipe In @ 5 O'Clock

Comments **The I5 pipe picture shows Channel deterioration.**

Condition: ☐ Sound ☐ Cracked ☐ Root Intrusion ☒ **Deteriorated** ☐ Leaks ☐ Debris

Infiltration: **Evidence** Pipe Seal Cond: **Unknown**
